Service Bulletin

SB No.FZ04071301N

Subject: FZBE Adjustment Pin Is Not Working Properly

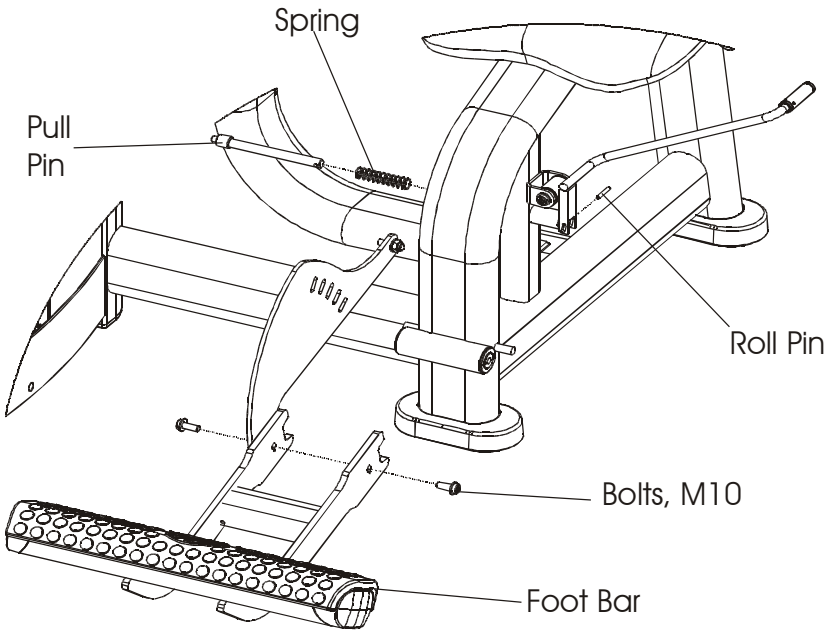
Adjustment pin is not working properly.

1. 7748701 Spring
2. 3110011 Roll Pin
3. 7767101 Pull Pin

1. Disconnect the gas spring from foot-bar. Use flat screwdriver to release metal clip.
2. Using a hammer and center punch, drive the roll pin out of the small hole in the pull pin.
3. Loosen two M10 bolts from the foot-bar, and then remove the foot-bar.
4. Replace the pull pin and spring.
5. Re-assemble as before.
